MADISON RIVER, MONTANA
REPORT ON
*FLOOD EMERGENCY
MADISON RIVER SLIDE*

*VOLUME I
MAIN REPORT*

U. S. ARMY ENGINEER DISTRICT, OMAHA
CORPS OF ENGINEERS
OMAHA, NEBRASKA
SEPTEMBER 1960

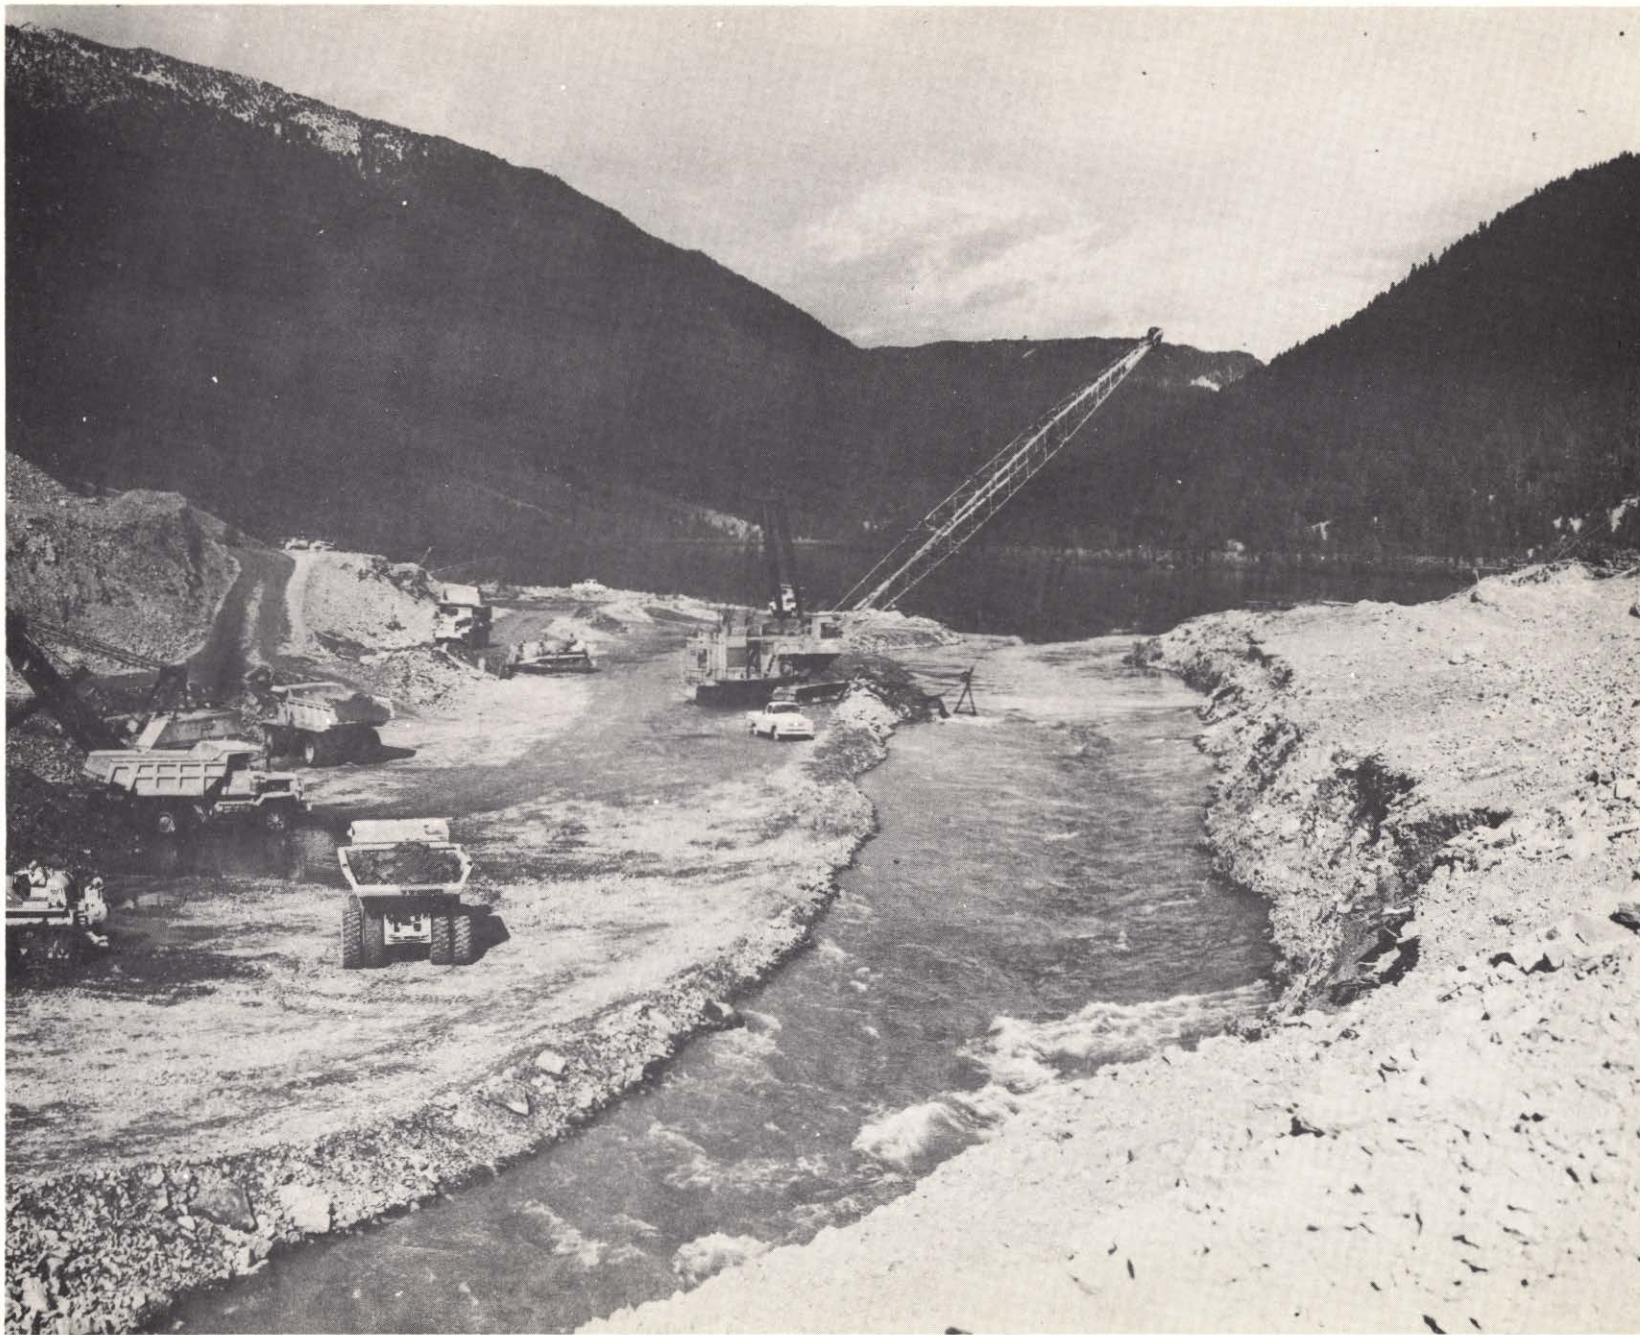
in rock movement in the spillway, at an estimated rate of 25,000 to 30,000 cubic yards per day. On the same day, two shovels arrived and were being assembled. By the following day, three shovels and eight end-dump trucks also were in operation. At the peak of activity, about mid-September, equipment working on the job included 27 dozers, 5 shovels, 29 end-dump trucks, 3 end-loaders, 1 patrol grader, 2 truck cranes, 5 light plants, 1 dragline, 1 water truck, 1 tractor-mounted drill, and one compressor, drill, and blasting outfit. A total force of 190 operators, oilers, foremen, and mechanics was required to keep the equipment in operation. Photos 3 and 4 show various pieces of the construction equipment in operation. Draglines brought in later show in photos 13, 21 and 22.

Photo 21. 11 October 1959. Large dragline lowering spillway channel near the outlet of Earthquake Lake.

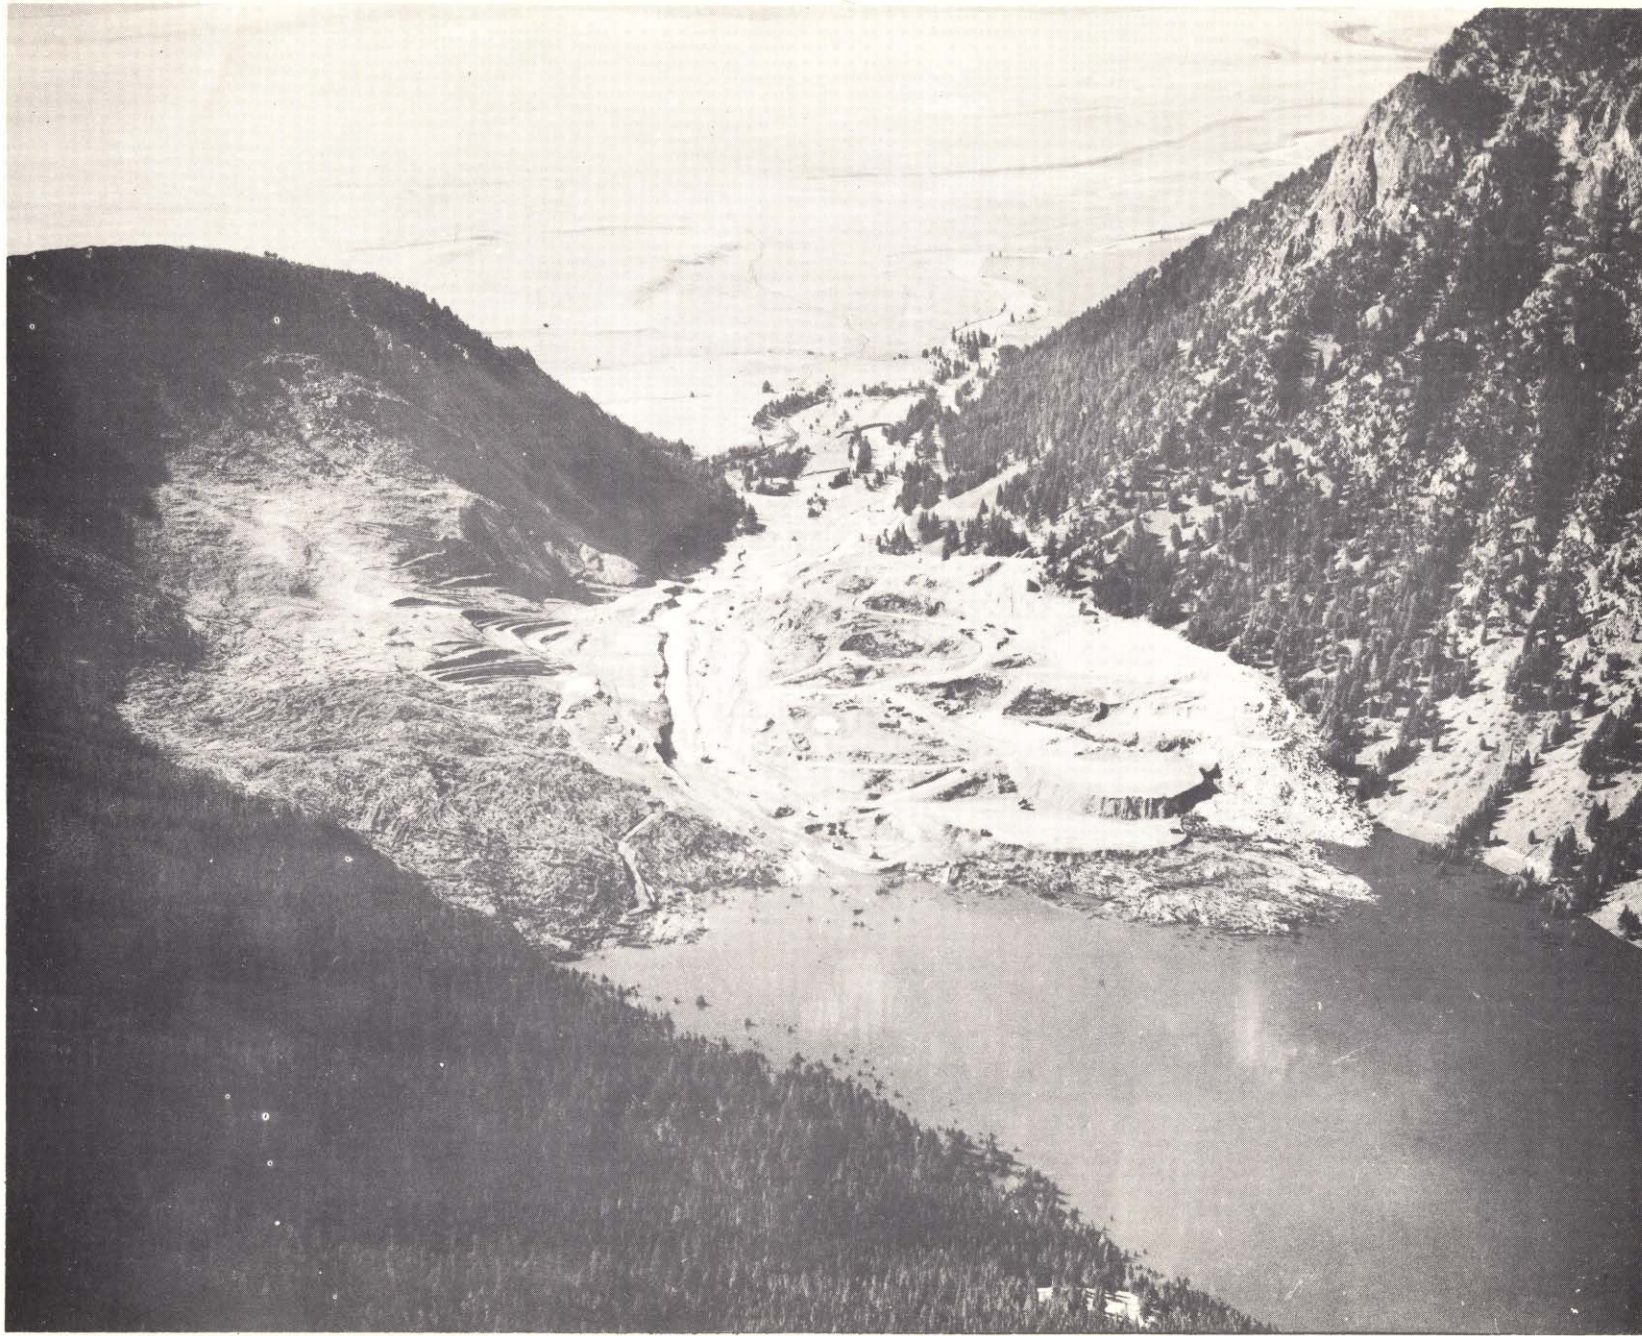
Photo 23. 17 October 1959. Aerial view of slide looking downstream.

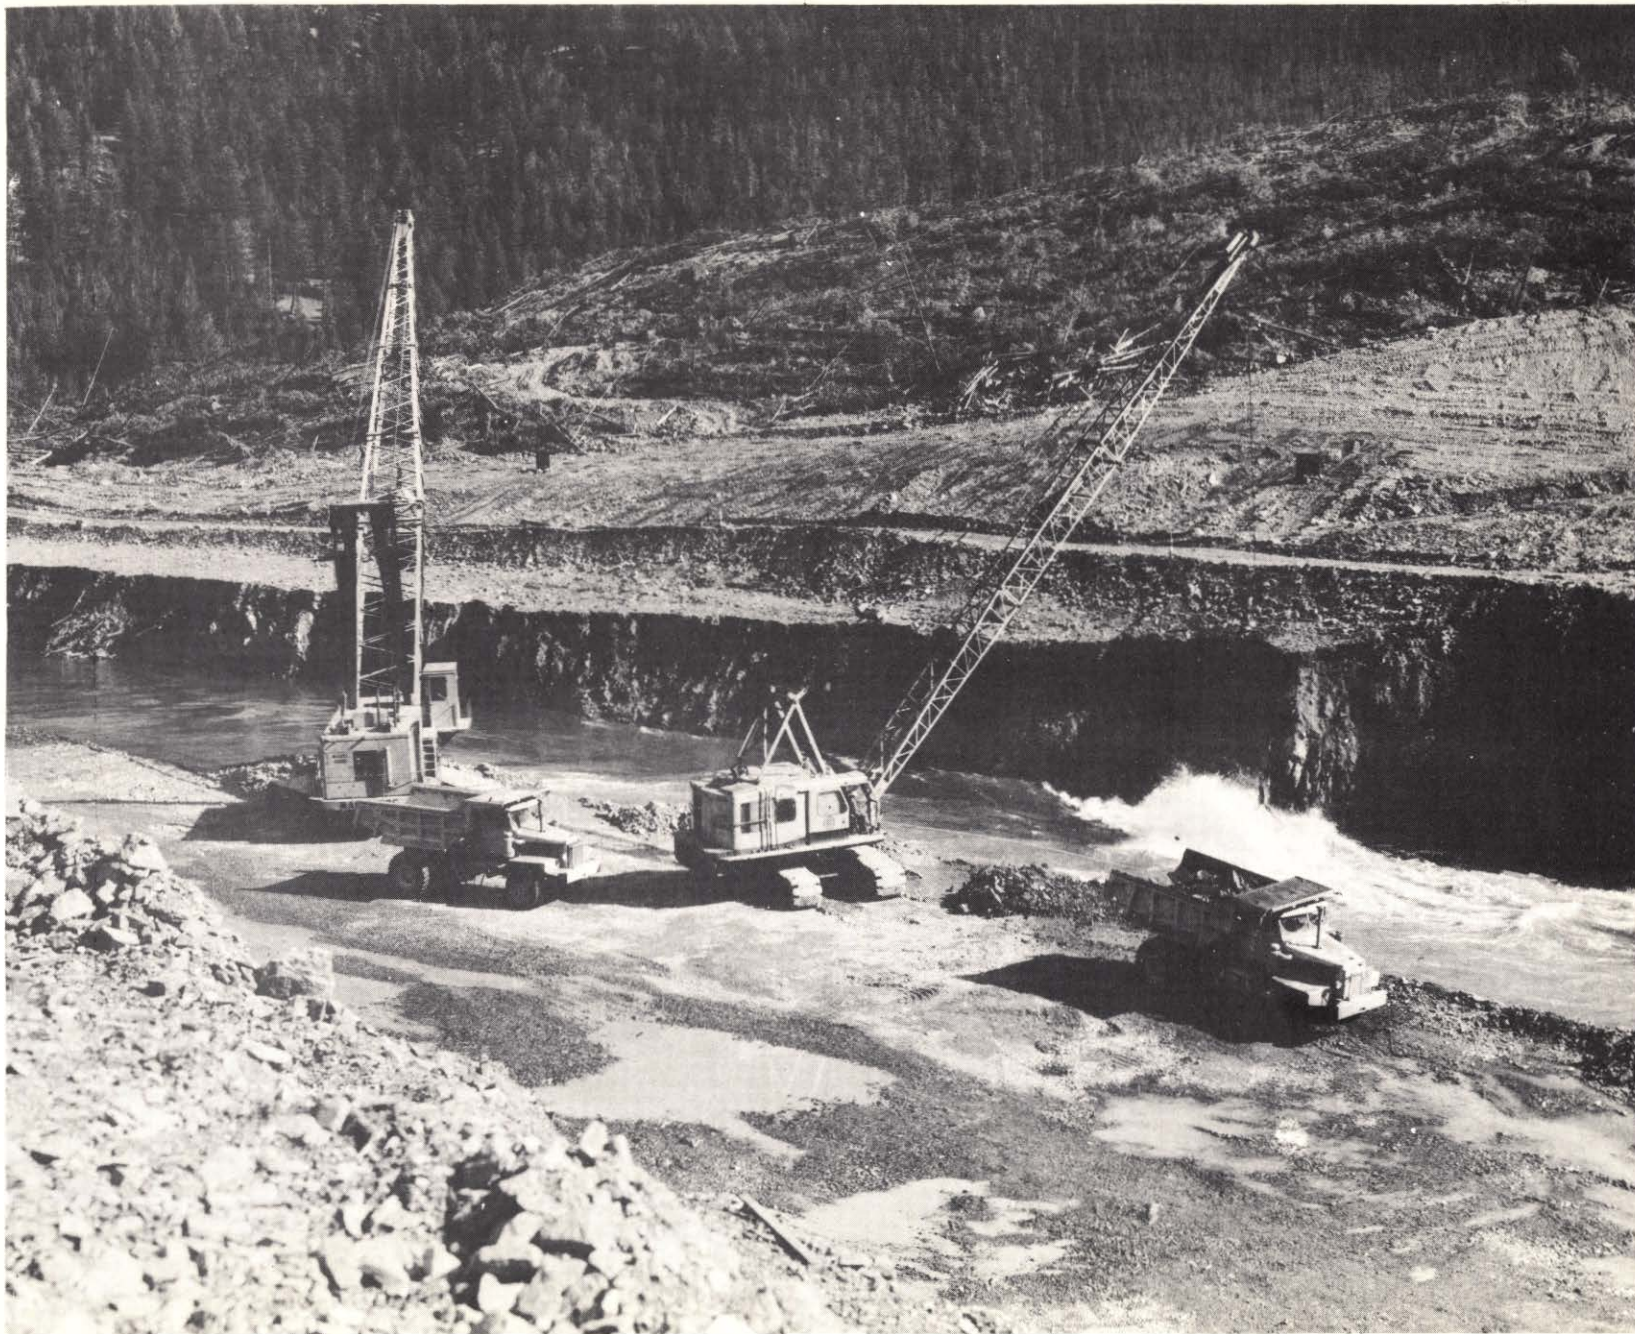
Photo 22. 14 October 1959. Draglines lowering spillway channel near Station 31+00.

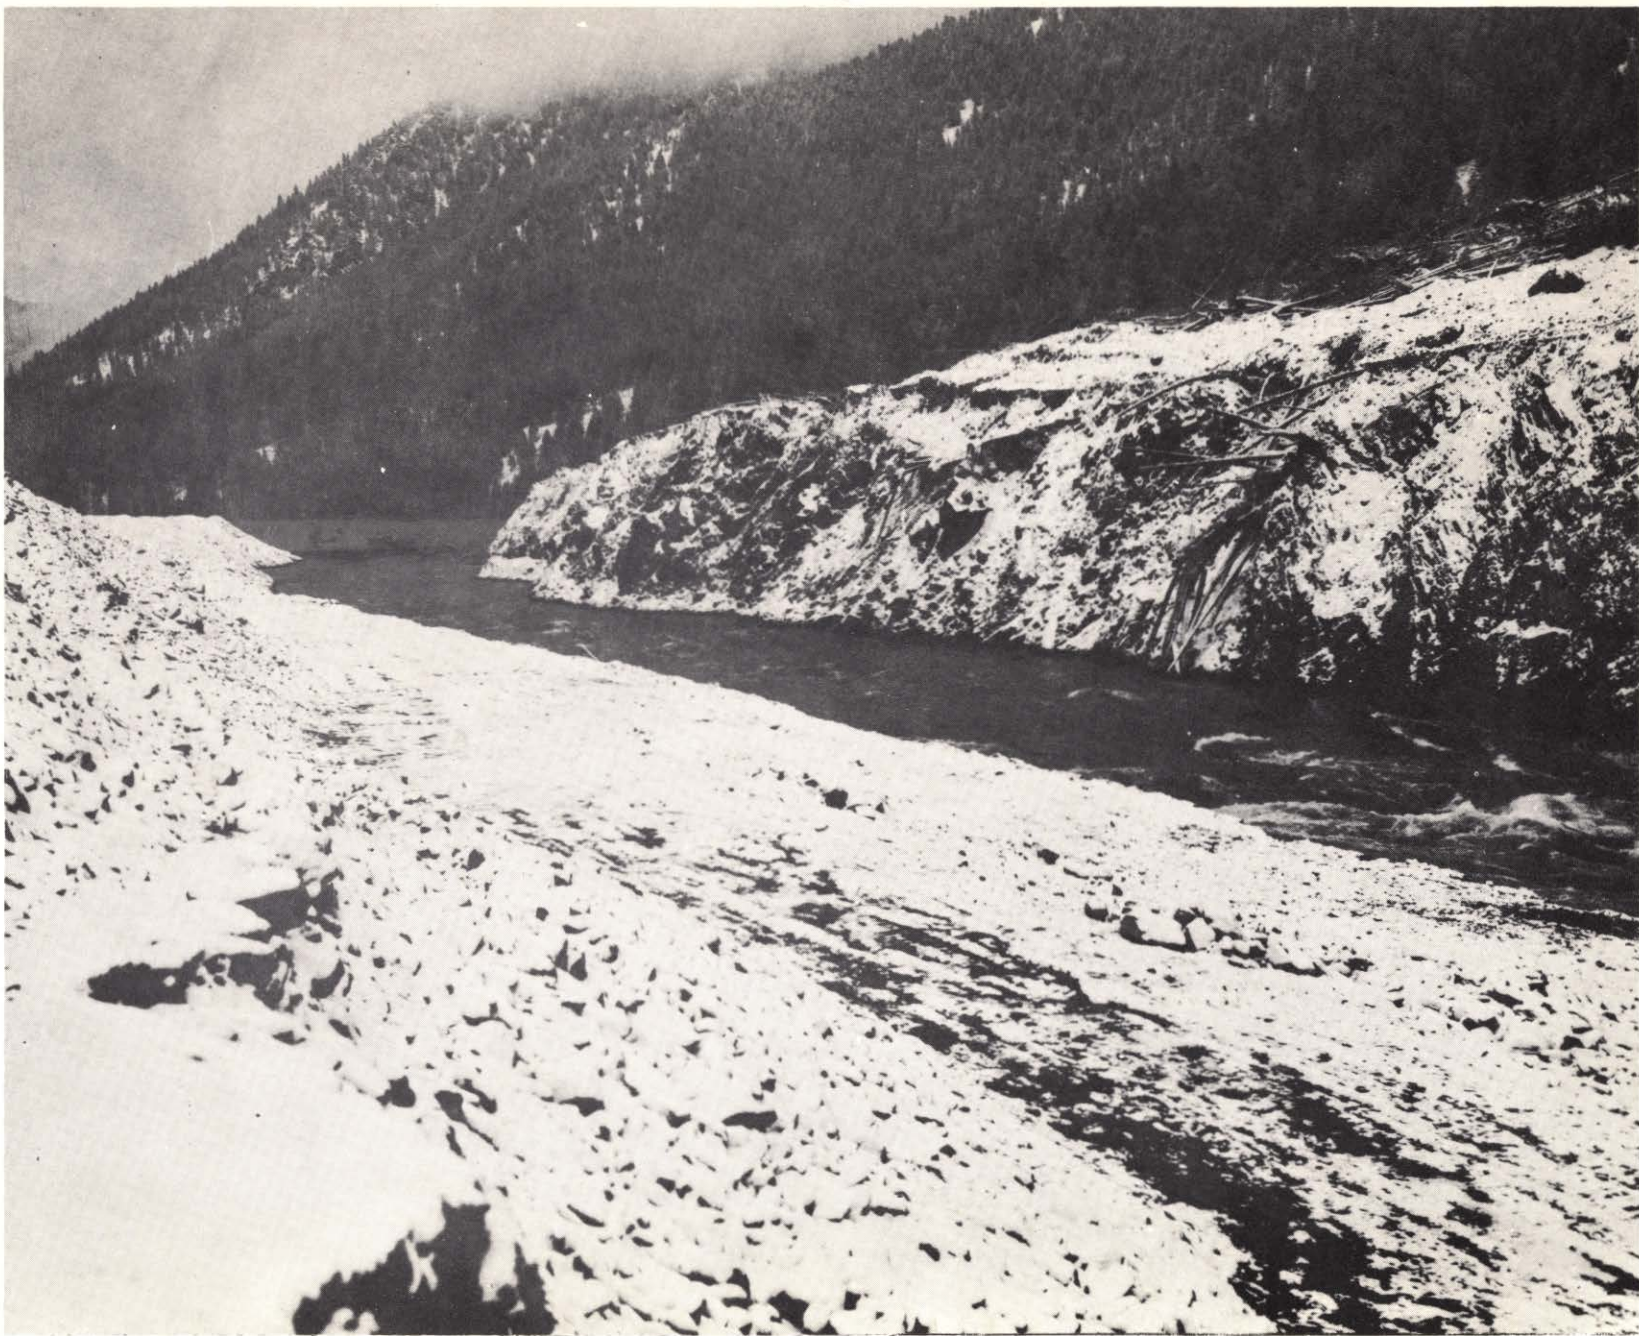
Photo 25. 29 October 1959. Completed spillway entrance looking upstream from about Station 30+00. Note high water line on trees about 50 feet above Earthquake Lake.

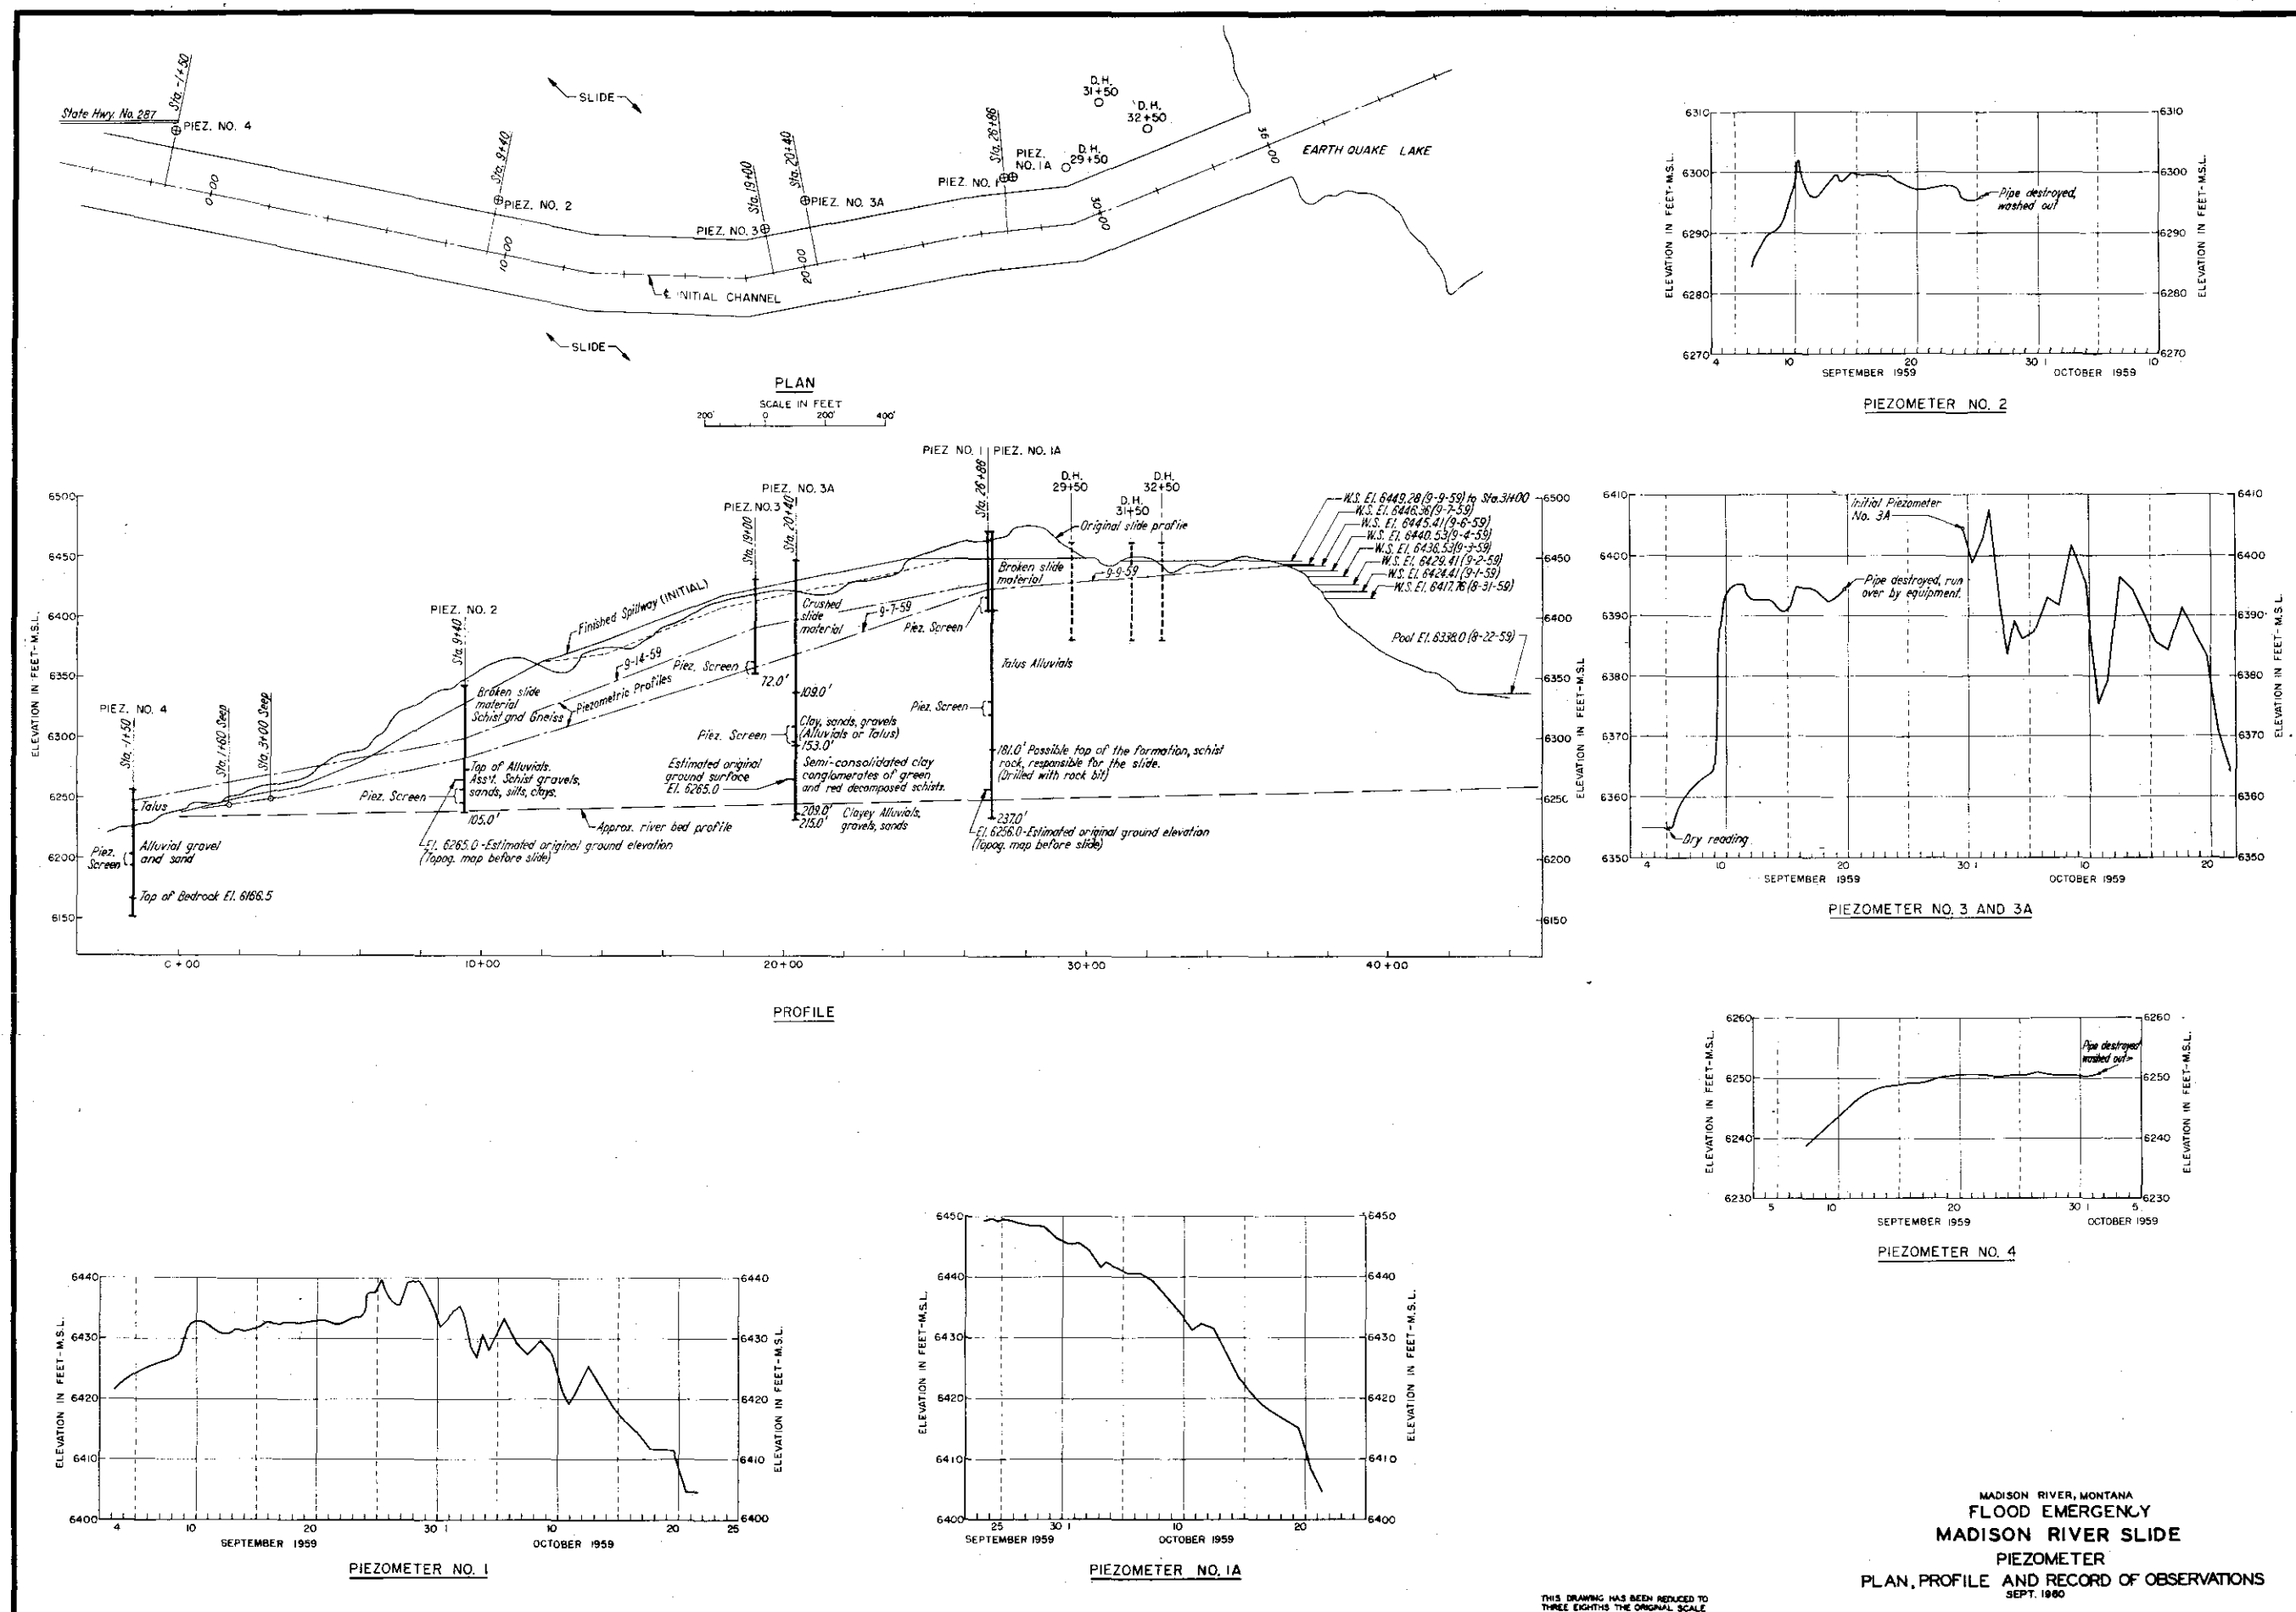
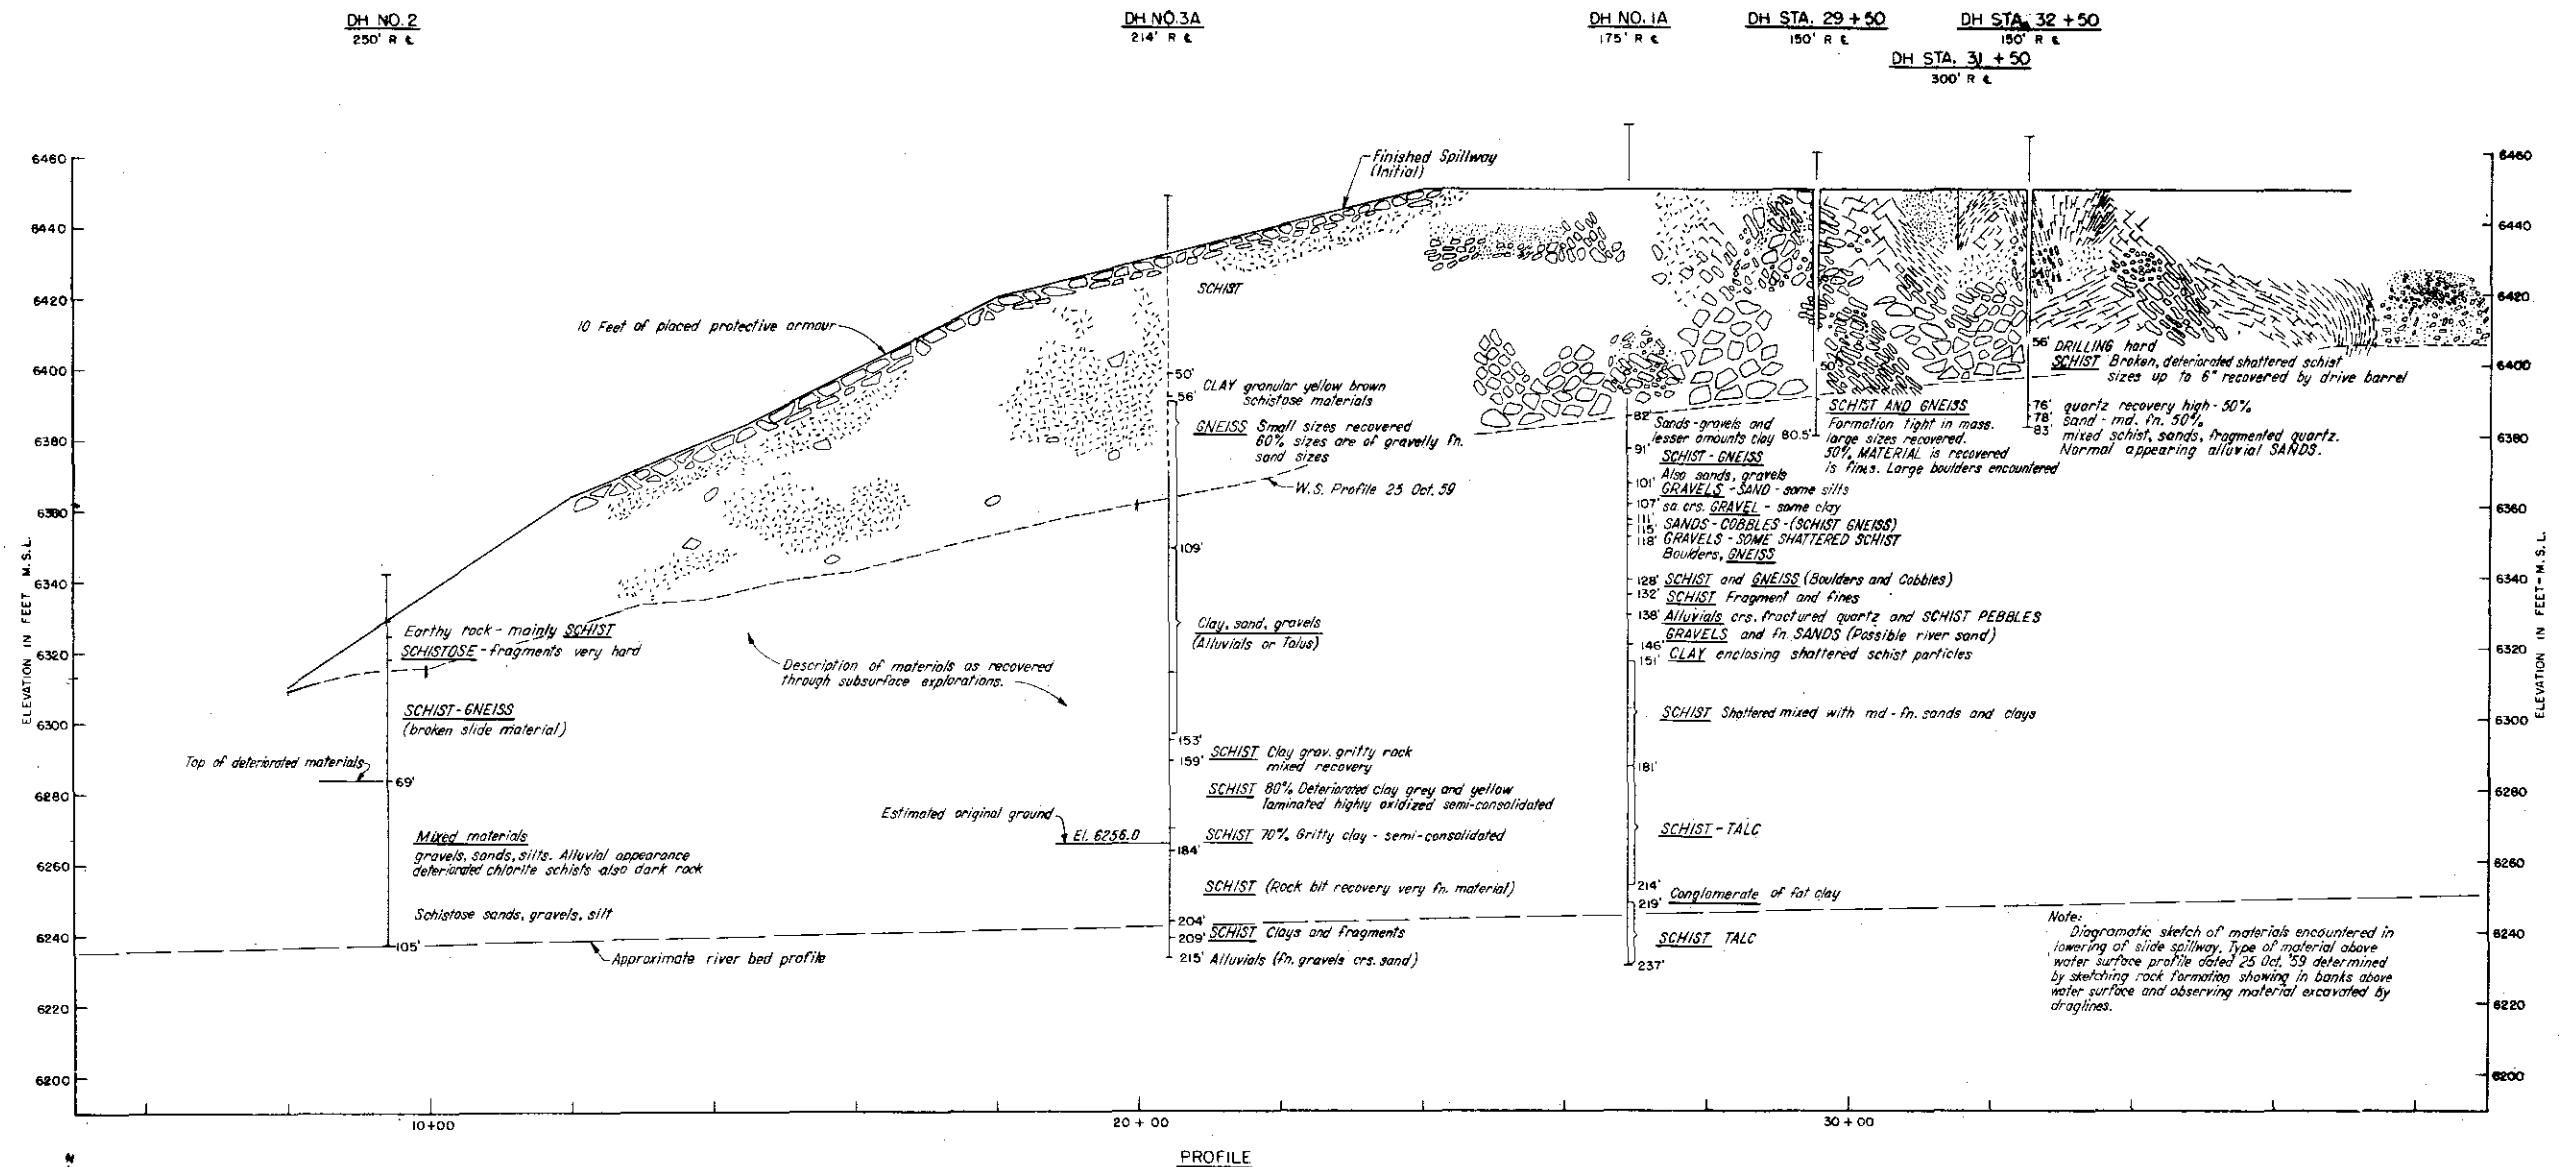
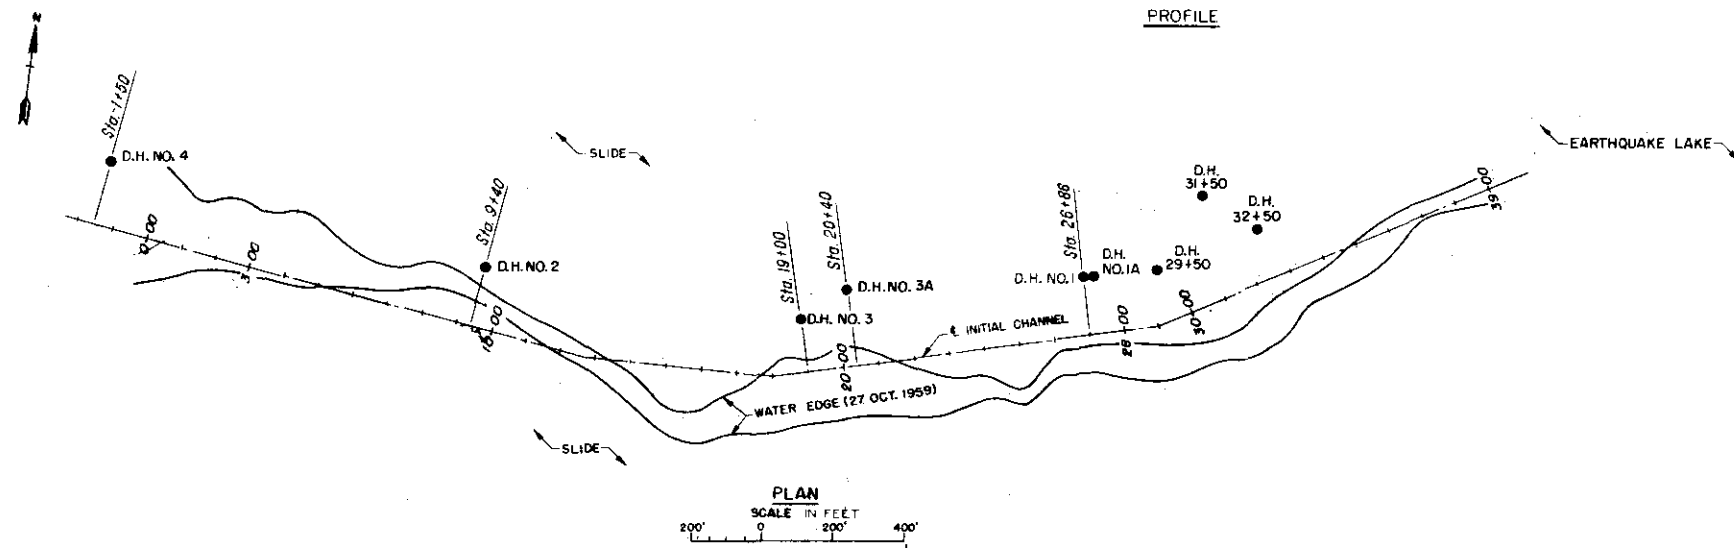
MADISON RIVER, MONTANA
FLOOD EMERGENCY
MADISON RIVER SLIDE
MATERIALS ENCOUNTERED IN
SPILLWAY AND DRILL HOLES
SEPT. 1960

67. Test holes. After the spillway lowering operation was started, three shallow test holes were drilled near the upstream part of the spillway channel. The rock formation was found to be continuous and apparently consisting of a mass of schist and gneiss which was fractured but not disturbed otherwise. The information obtained from these test holes indicated that a resistant rock formation extended at least to elevation 6380 at the location of the spillway channel. Locations of the test drill holes and data on materials encountered are shown on plate 16.

68. Materials in channel. As the lowering of the spillway progressed the exposed banks and slopes were studied in detail. Sketches and photographs were made, as well as record notes of the types of materials exposed. From this information, a generalized geologic drawing was made showing the rock formations encountered in the spillway excavation. The generalized geologic drawing is shown on plate 16; additional photographs of the chute walls are included in Appendix X.
